PdMsolutions
Machinery Condition Report
for
Chemical Company
27-29 April, 2004
Washington, New Jersey

Report Date:
3 May, 2004

Report Number:
040495BP

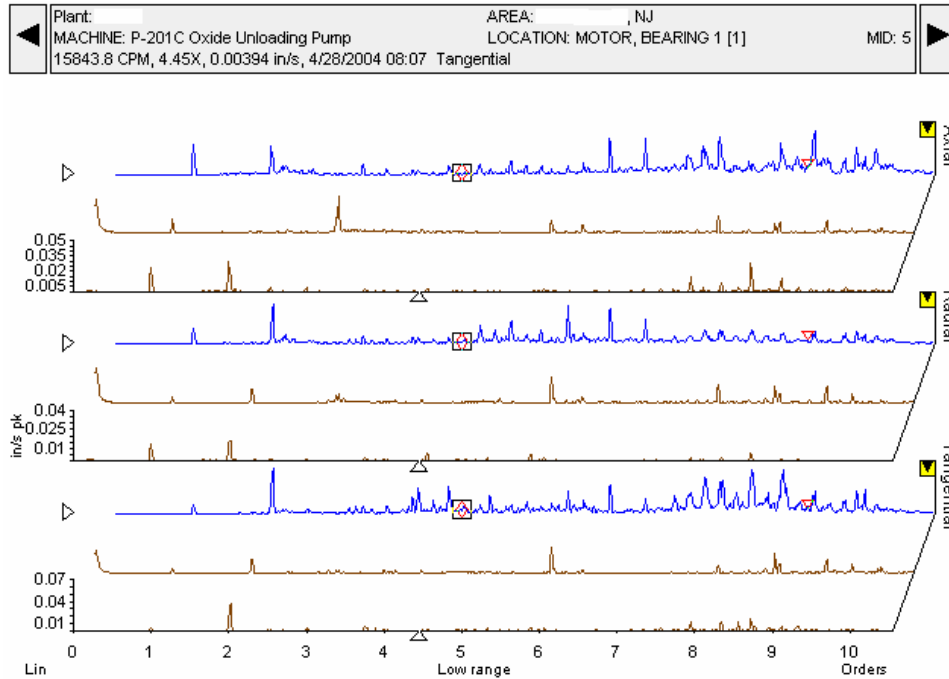
4.1) P-201C Oxide Unloading Pump

SERIOUS MOTOR FREE END BEARING LOOSENESS

SERIOUS MOTOR FREE END BEARING WEAR

SERIOUS MOTOR DRIVE END BEARING WEAR

MODERATE PUMP BALL BEARING WEAR

Analyst Comments: Pump bearing indications appear to be coming from the motor fault. Motor bearing should be replaced.

IMPORTANT: REPLACE MOTOR BEARINGS

DESIRABLE: MONITOR PUMP BEARINGS FOR INCREASED VIBRATION

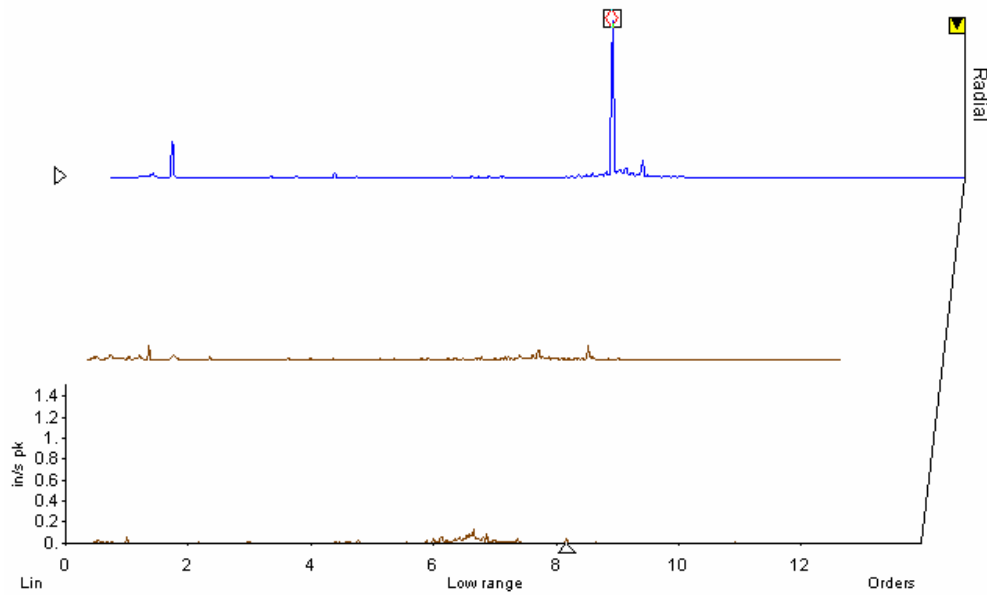
4.2) A407 Reactor

MODERATE INDICATION OF POSSIBLE MOTOR FREE END BEARING WEAR

MODERATE MOTOR TO GEARBOX ANGULAR MISALIGNMENT

MODERATE SECOND GEAR MESH PROBLEM OR WEAR

SLIGHT MOTOR ROTATIONAL RATE VIBRATION

Analyst Comments: Vibration levels continue to increase. The increase is most notable on the Motor Non Drive End. It appears that the response is being induced from the Gearbox and is most likely due to the gear mesh frequency of the low speed shafting. The speed that the unit was tested at was less than the previously collected data; as a result the response measured could possibly be due to the excitation of a system resonance at the lower speeds. In any event amplitude levels are excessive and actions should be taken to reduce the high levels in the overhang. Further testing would be required to confirm resonant response. Additional information is required to fully access the exact cause of the fault. At present no bearing or gear information is available. It would be helpful if Motor, Gear and Output shaft bearing information was available. Also to confirm Gear Mesh activity the number of teeth on each of the gears is required. Response at 8.18X running speed has increased at all measured locations.

DESIRABLE: MONITOR ALL MOTOR BEARINGS FOR INCREASED VIBRATION

DESIRABLE: ALIGN MOTOR TO GEARBOX.

DESIRABLE: MONITOR DRIVE GEARS FOR INCREASED VIBRATION

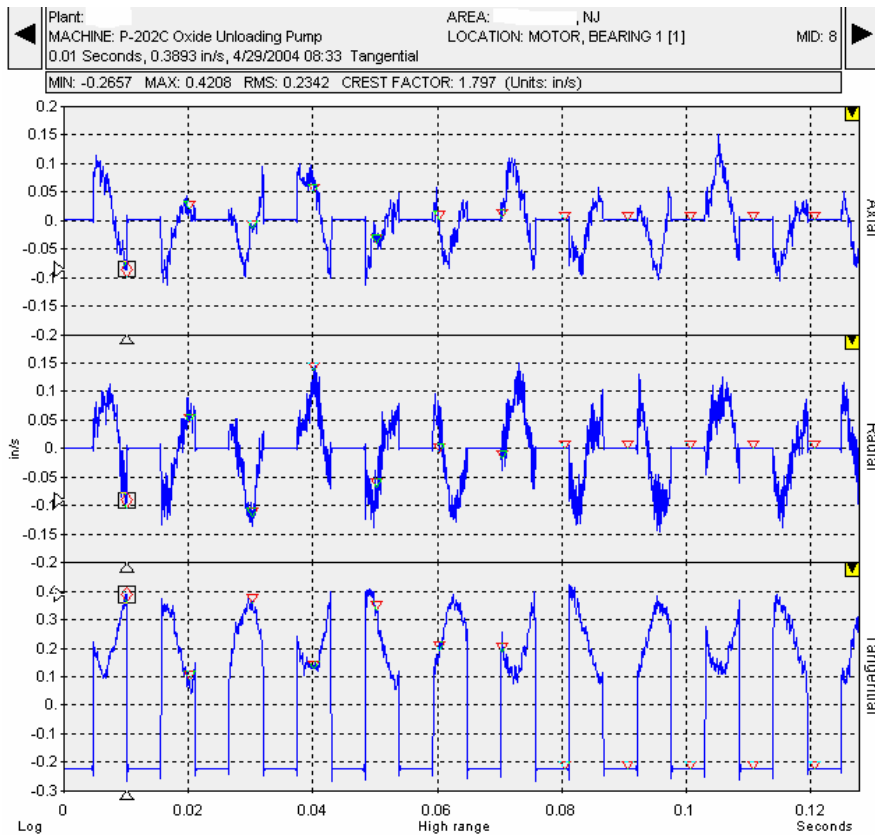
4.3) P-202C Oxide Unloading Pump

MODERATE MOTOR FREE END BEARING WEAR

MODERATE PUMP BALL BEARING WEAR

MODERATE COUPLING ROLLING CONTACT BEARING WEAR

MODERATE MOTOR DRIVE END BEARING WEAR

Measured response appears to be due to data collection problem. This is based on observation of time waveform which shows overlapping gated timing response at all measured locations. It is very unlikely to be a machine problem.

- DESIRABLE: MONITOR PUMP BEARINGS FOR INCREASED VIBRATION
- DESIRABLE: REPLACE MOTOR BEARINGS
- DESIRABLE: REPLACE COUPLING ROLLING CONTACT BEARINGS
